**Restoration  
of  
CULVER CADET  
NC 32482  
Mgf. 1941**

**by  
Ed Byars  
and  
Jerry Reider**

**Seneca, SC  
2002-2005**

# CULVER A/C LOG BOOK ENTRY 10/20/05

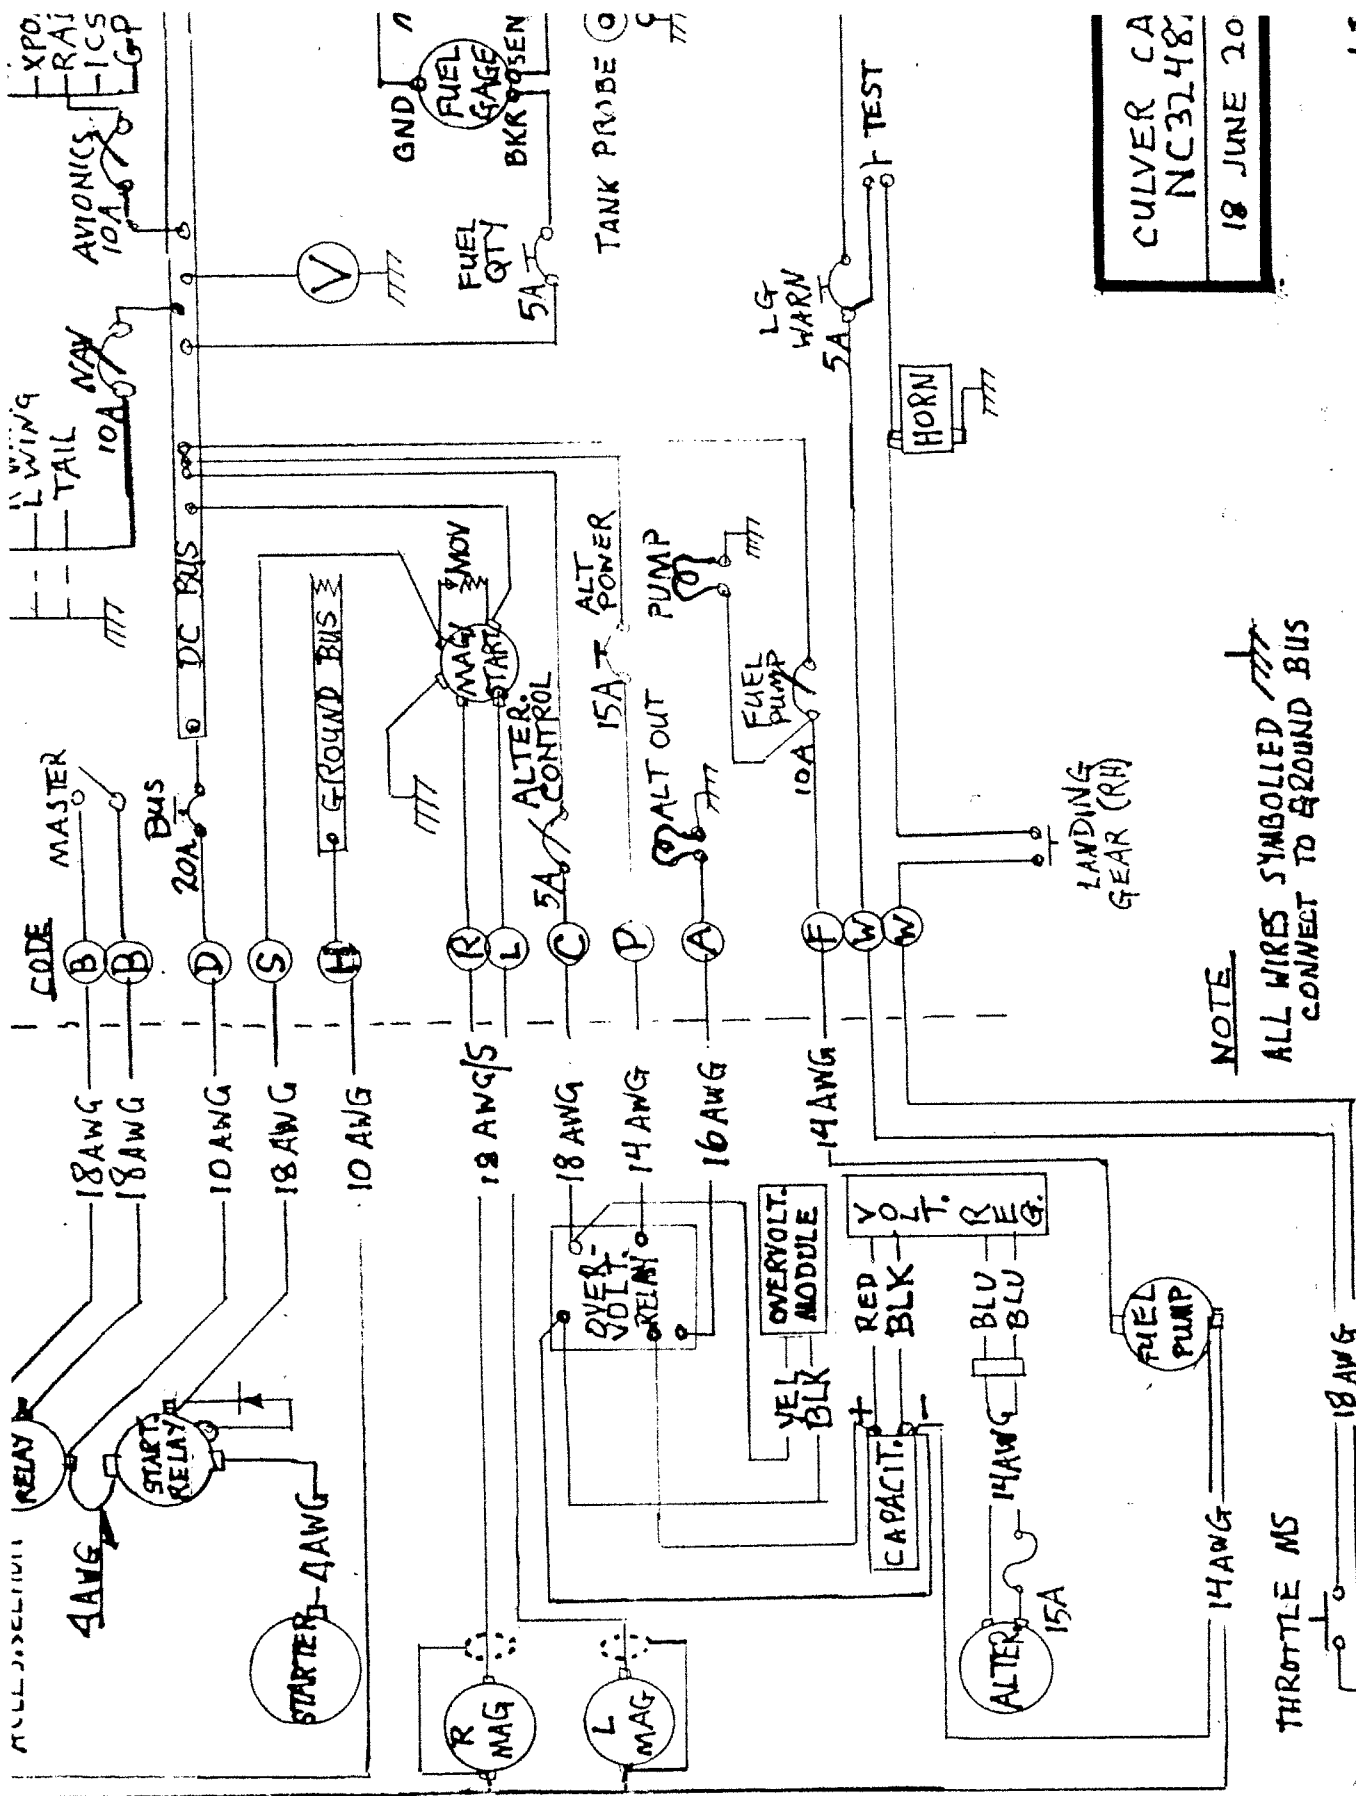
CULVER CA  
 NC32487  
 18 JUNE 20

2. Removed OEM Delco Generator and Regulator and installed B&C Model 200G Alternator, Model PMR1-14 Regulator, OVM-14 over voltage module and 10Kuf capacitor IAW with manufacturer's Drawing 504-500 and Instructions. Wiring was replaced with new of same gage. This installation was previously approved N2759K (10/9/03) and N72182 (8/27/03). Both aircraft had C-85-12 engines.
