DEPARTMENT OF COMMERCE  
CIVIL AERONAUTICS ADMINISTRATION  
WASHINGTON

SAFETY REGULATION RELEASE NO. 129

**SUBJECT:** Prevention of Engine Mount Failures in Low Powered Aircraft.

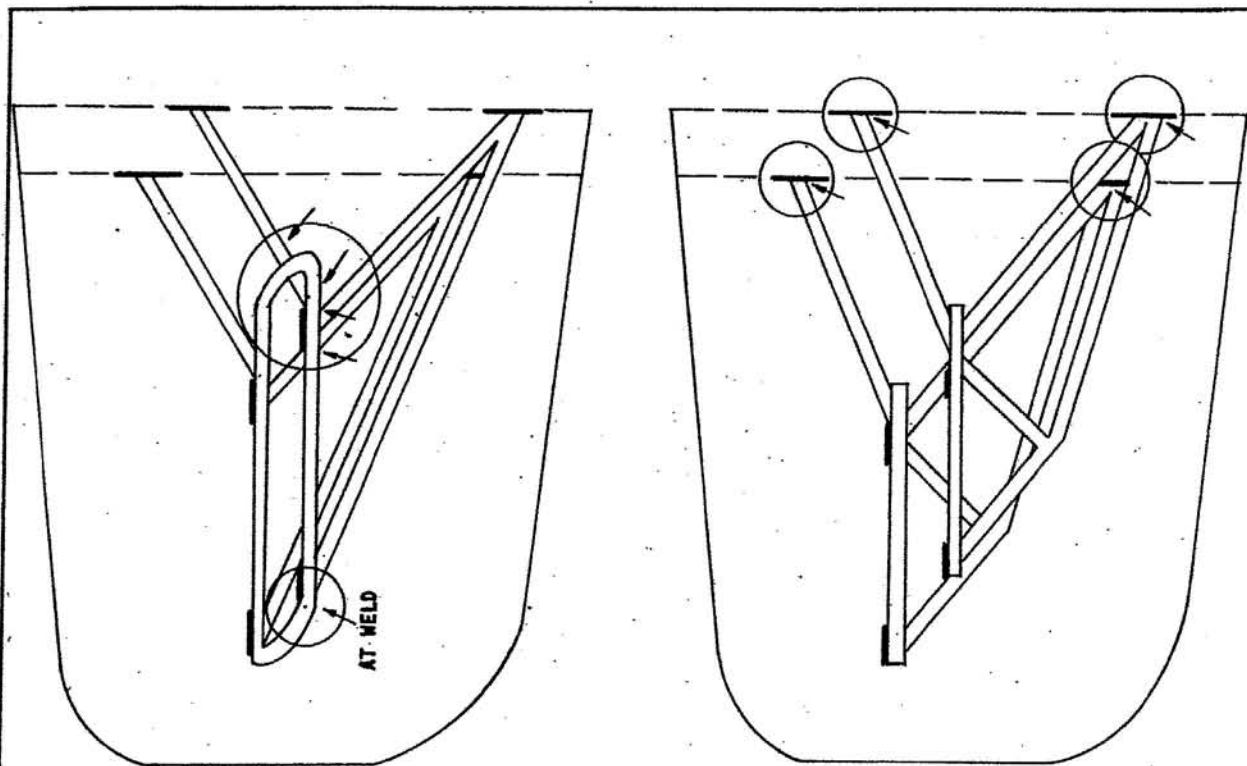
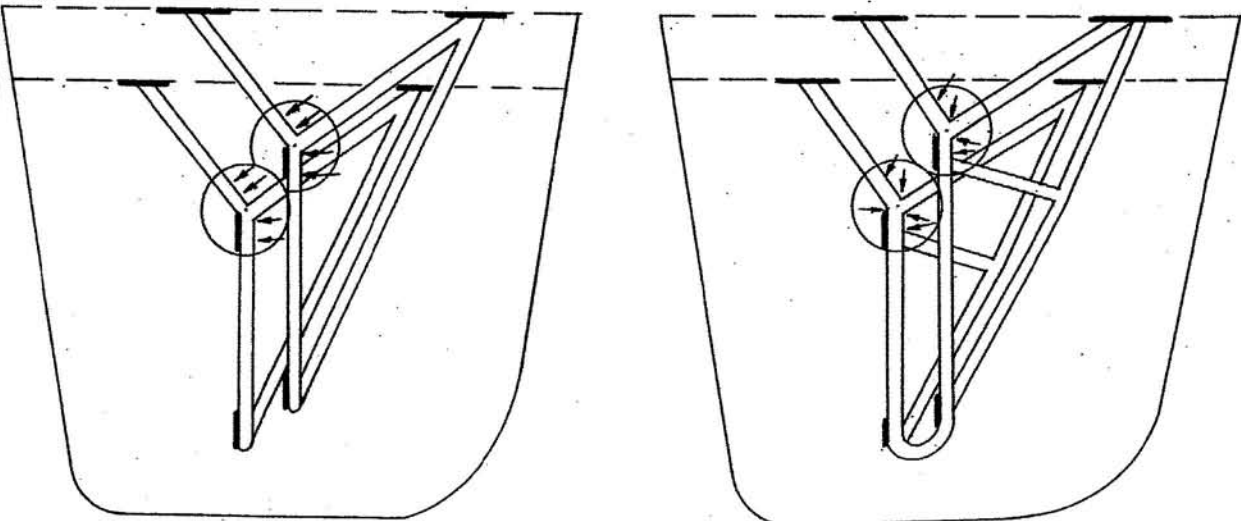
FIGURE 2  
LOCATION OF TYPICAL ENGINE MOUNT FAILURES

The number of reports of engine mount failures recently received indicates that such failures are becoming chronic for several models of light aircraft powered by 4-cylinder opposed type engines and incorporating the platform type engine mount (See Fig. 2). None of the reported failures has so far resulted in a serious accident but the nature of the failures indicates that a serious accident might occur if remedial action is not taken.

The reported failures are usually cracks found in or near welded joints and are principally due to recurrent resonant vibration. As you know, most engines have "rough" spots at certain RPM values at which the engine will vibrate somewhat more than usual. The vibration responsible for fatigue cracks occurring in these mounts is due to the engine vibrating about its thrust axis, and is produced by the firing impulse frequency from the engine (2 times crankshaft RPM). A great many experimental changes have been tried on platform type engine mounts to reduce or eliminate the engine mount frequency responsible for these failures. The problem can be overcome, but thus far it requires greater weight, complication and cost. Until such time as permanent corrective measures have been determined, it is believed that the steps listed below will result in safer operation and will reduce the occurrence of cracks in the engine mounts.

ARROWS INDICATE  
POINTS OF FAILURE

Vibration is always undesirable and in many cases it will produce such failures as are indicated above. In addition, it will cause a general deterioration of the airplane structure and is apt to produce power plant failures due to the failure of fuel and oil lines, or malfunctioning of the various components. Vibration cannot be eliminated but, in many cases, it can be greatly reduced by avoiding engine operation at "resonant" speeds (RPM's). Therefore, it is recommended that the following brief checks be performed on each airplane you own equipped with a "flat four" engine on a platform type mount (See Fig. 2 for example of the type of mount).

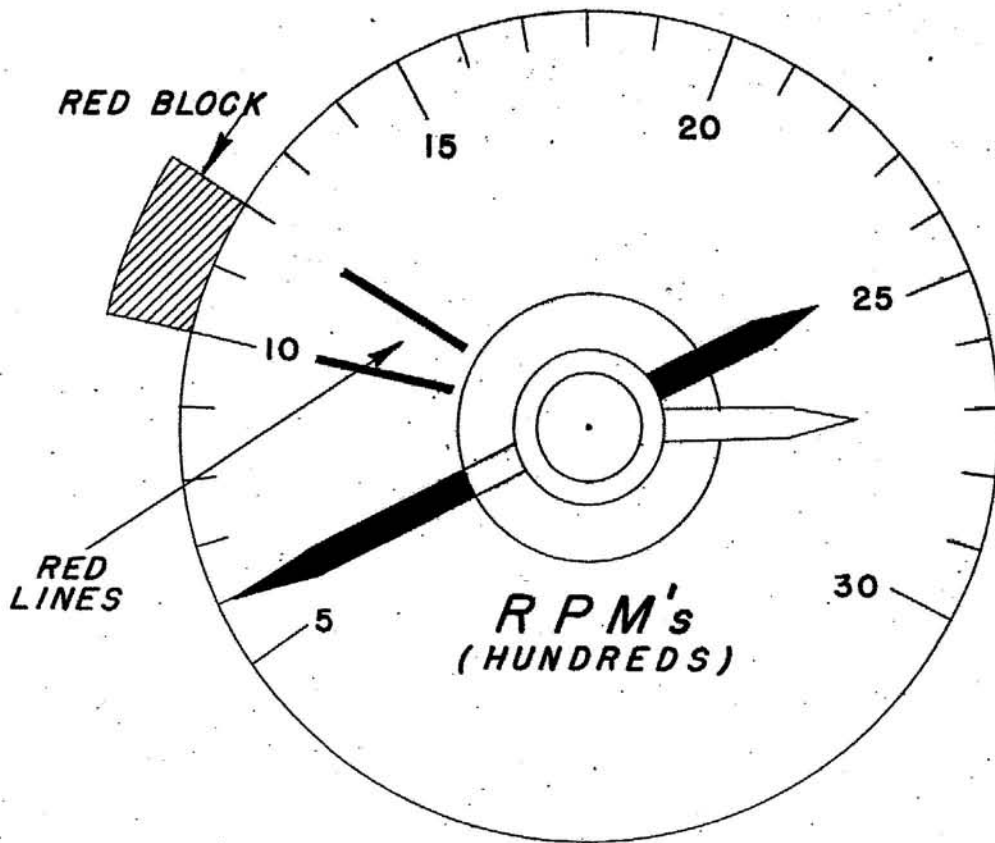
FIGURE 1

TACHOMETER MARKINGS

4. This rough speed may then be indicated essentially as shown on the attached sketch (Fig. 1), on or near the glass face of the tachometer in order to remind pilots that continued operation within 100 RPM of this speed is to be avoided. For example, Figure 1 is marked to indicate a resonant vibration speed which had been found to exist at 1100 RPM.
5. If it is known that an airplane has been subjected to excessive vibration for any appreciable length of time, it is advisable that the engine mount be visually inspected for cracks before further operation is attempted. In any event, a careful visual inspection of the engine mount should be made at the time of the next periodic inspection of the airplane. The engine and mount need not be removed from the airplane for this inspection.
