CULVER AIRCRAFT CORPORATION
WICHITA, KANSAS

MEMORANDUM TO CULVER LCA & LFA OWNERS

NO. 2

SUBJECT: INSPECTION AND MAINTENANCE OF THROTTLE INTERCONNECTION WITH LANDING GEAR CONTROL.

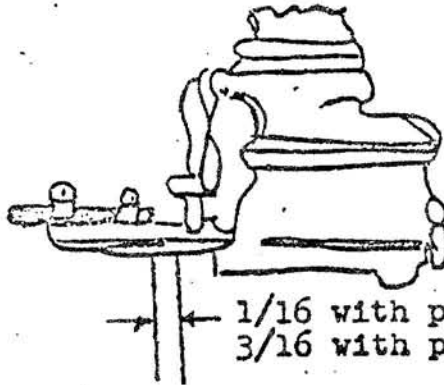
Fig. 1A

1/16 with play out
3/16 with play in.

Model LCA
Half Travel
Indicated

A careful inspection should be conducted to determine that all connections are in proper order. The clamps at either end of the cable housing should be checked to make absolutely sure that they are holding the housing secure against any possible chance of slippage, this being the most important part of this requested inspection. For this inspection to be sufficiently thorough, the airplane should be blocked up and the gear retracted, observing the action of the interconnection. The plunger position should be so adjusted that the throttle can not be pulled back unless the gear is down and locked. In this connection, a play of approximately 1/8" in the flexible control will be observed, and is to be expected in this type of control. The effect of the play is neutralized by adjusting the plunger to clear the throttle quadrant by 1/8" when the flexible control is stretched from the plunger end. When the control is pushed from this end the clearance will then be approximately 3/16". See Fig. 1.

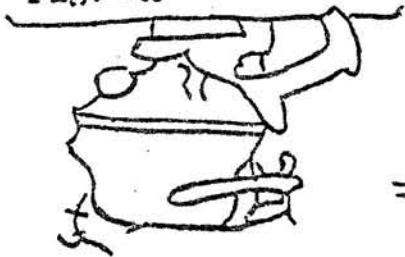
Fig. 2A

1/16 with play out
3/16 with play in.

Model LFA
Full out
indicated

The plunger must not be able to go in front of the quadrant when the throttle is closed. This condition will not exist if the throttle stop is correctly adjusted to give 1750 R.P.M. in level flight. See Fig. 2

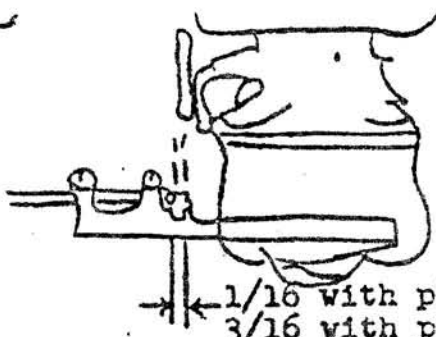
Fig. 2B

NOTE: Plunger to be in this position when idling with reference to quadra Never to be in fron
