CULVER AIRCRAFT CORPORATION
WICHITA, KANSAS

SERVICE MEMORANDUM

NO. 10

SUBJECT: Clearance Between Bottom of Rudder and Tab Cable Channel
Over Stabilizer.

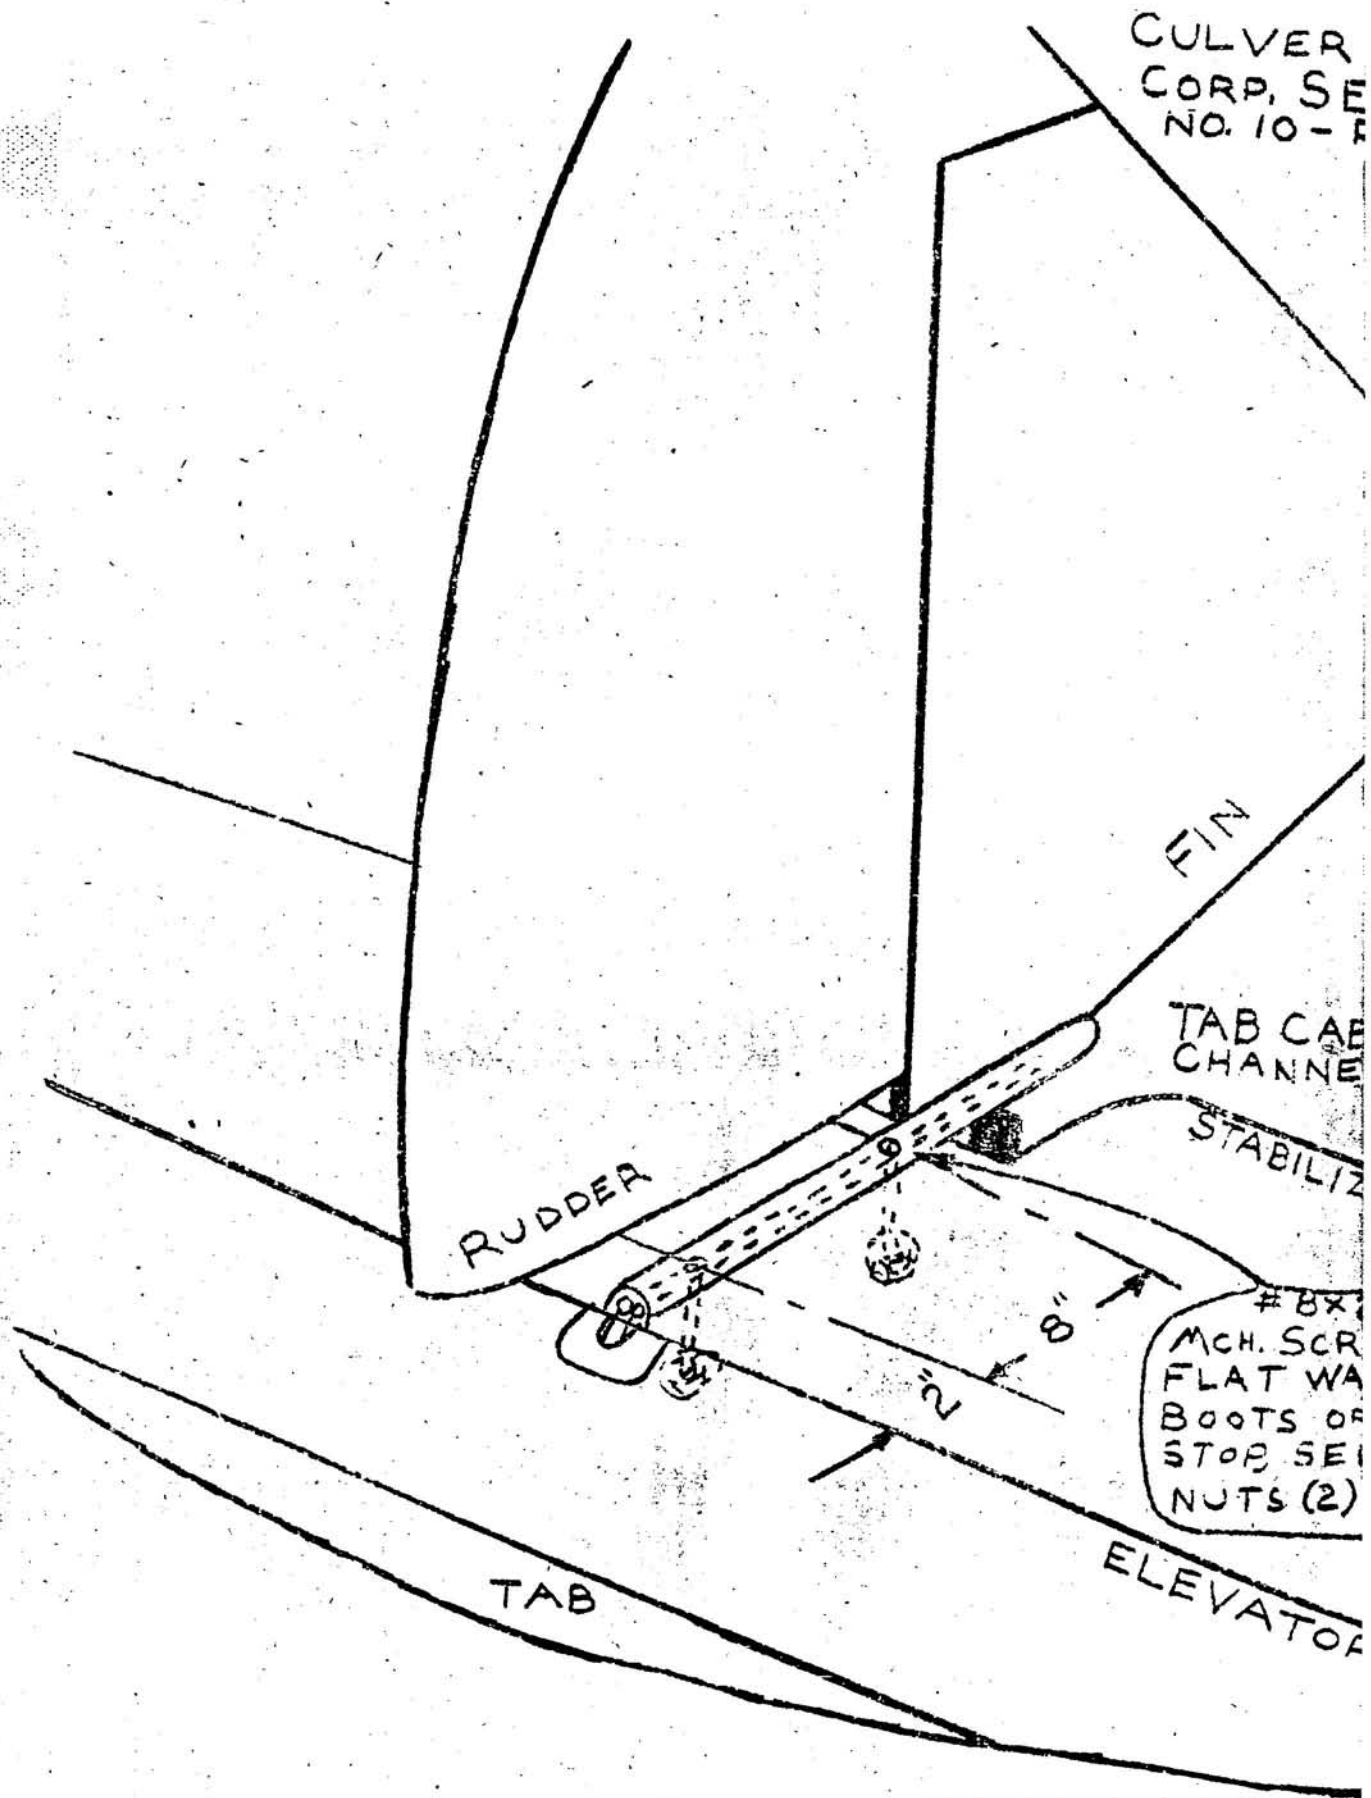
FIGURE 1

1. The tab channel on airplanes between the above serial numbers was fastened to the stabilizer by means of screws into the plywood upper surface. These screws have been known to work loose in service allowing the tab cable channel to raise up and possibly interfere with the rudder action.

2. The screws should be replaced by two machine screws, with self-locking nuts extending completely thru the stabilizer in the locations given in the accompanying diagram.

3. There should be at least 1/8 inch clearance between the bottom of the rudder and the tab channel or center elevator hinge bracket. The head of the machine screw may have to be filed down in one or two cases to get this minimum clearance.

4. If there is less than the minimum clearance, the lower panel of the rudder will have to be uncovered and the trailing edge of the bottom rib moved up to give ample clearance (preferably 1/4 inch to 3/8 inch).
