CULVER AIRCRAFT CORPORATION
WICHITA, KANSAS

NO. 11

SERVICE MEMORANDUM

SUBJECT: Alteration and Maintenance of Cooling Baffles of Culver Model LFA (Franklin Powered).

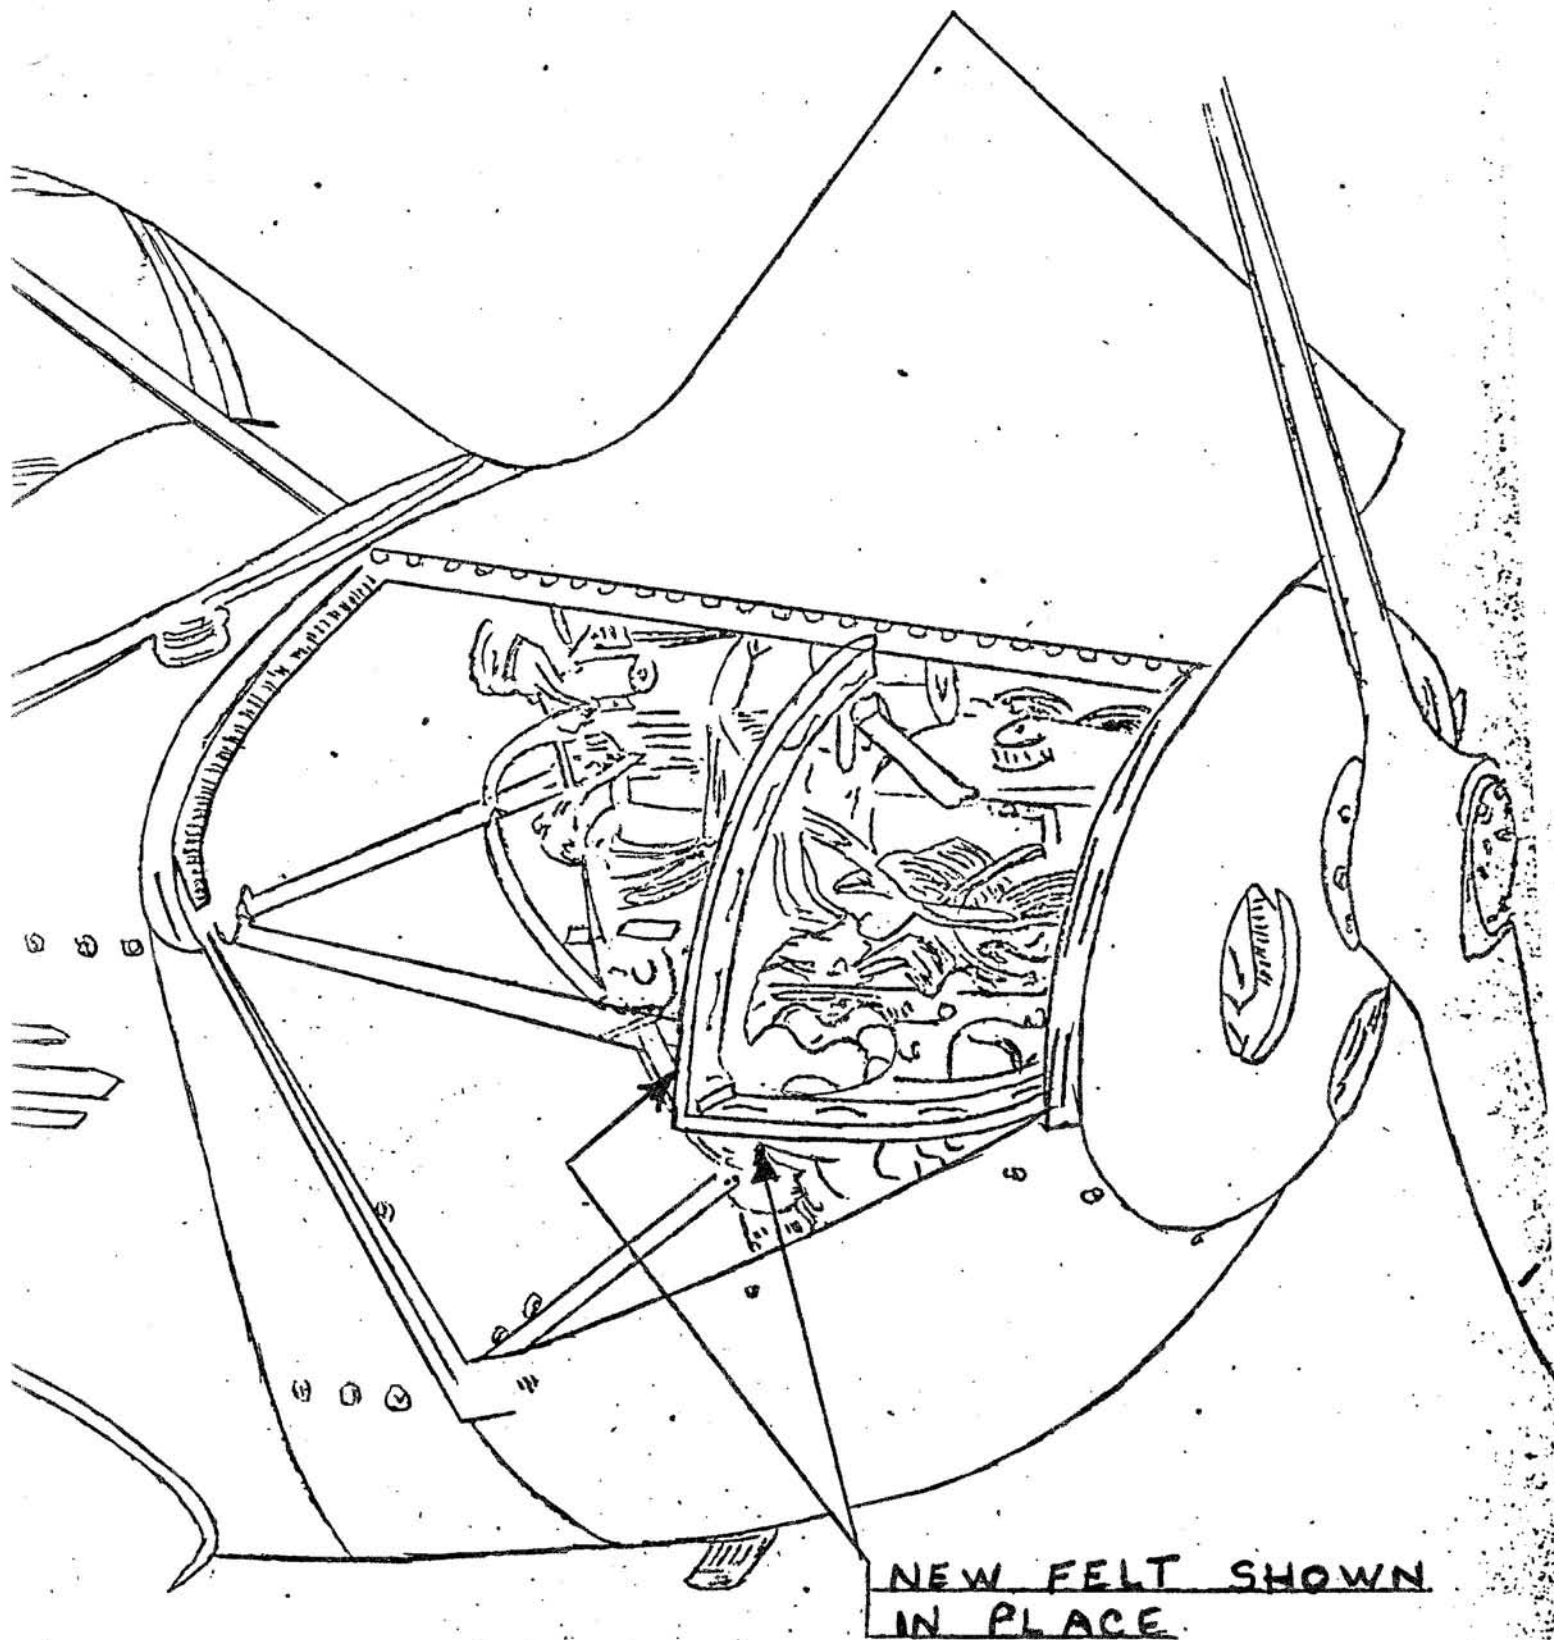
FIGURE 1

1. It has come to our attention that in certain cases the engine cooling on airplanes of the subject model has varied greatly in excess of the original approved limits after some service time has elapsed. A joint study by Aircooled Motors, the engine manufacturer, and this company has clearly shown that in every instance this overheating has been due to the deterioration of the leather facings on the cooling baffles, thus allowing air leakage between the baffles and the cowling. In some cases the baffles themselves have been mutilated or otherwise deformed, probably during service work on the airplane.

3. Service has shown that the leather facings on the baffles lose their resiliency with heat and time. To correct this situation, we strongly recommend the following procedure: Replace the leather with 1/2" thick hard felt in accordance with Figure 4, making sure that the baffle plates clear the cowling by 1/4" and that the felt extends 1/2" beyond edge of plate. To do this, nose cowl must be removed as indicated in Fig. 3 and all leather replaced by felt. SAE F-6, F-7, F-12, F-13, or F-15 is suitable for the purpose. If none of these grades may be obtained locally, the Culver Service Department will forward enough strips for one airplane at cost of \$0.85 upon request, postage prepaid. Do not use any other type of felt than specified. Figs. 1, 2, and 3 show the proper installation of the felt.

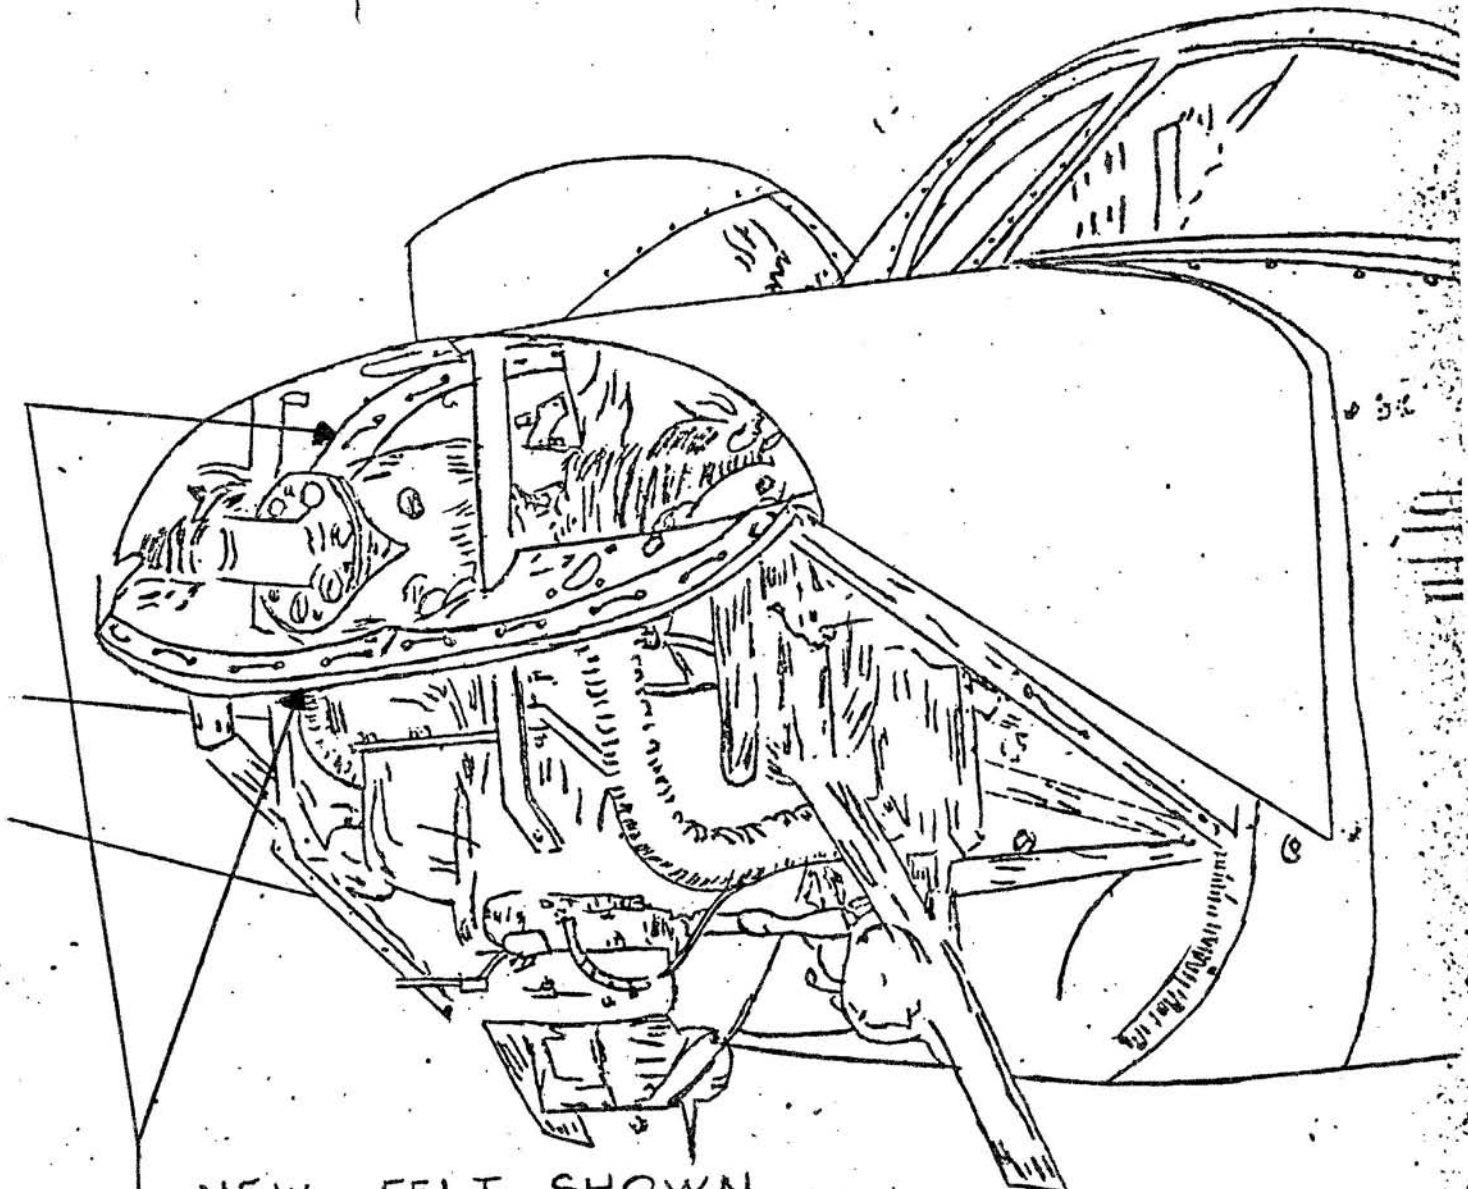
FIGURE 2

NEW FELT SHOWN
IN PLACE

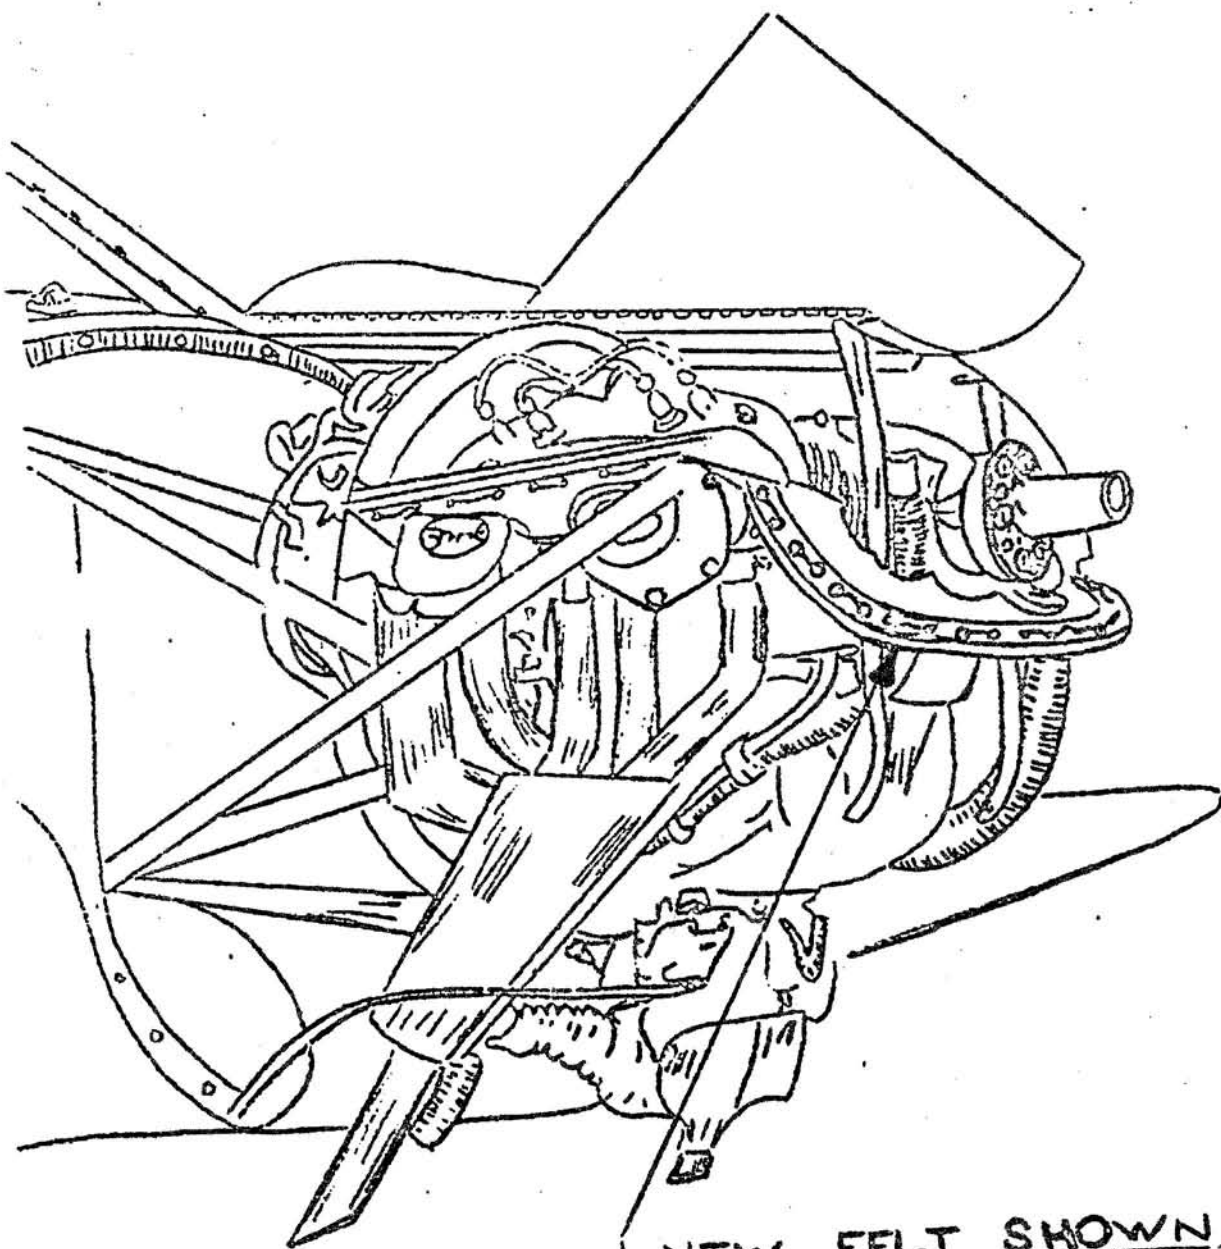
FIGURE 3.

NEW FELT SHOWN
IN PLACE |
