CULVER AIRCRAFT CORPORATION
WICHITA, KANSAS

SERVICE MEMORANDUM

NO. 12

SUBJECT: Alteration of Front Stabilizer Attachment to Fuselage.

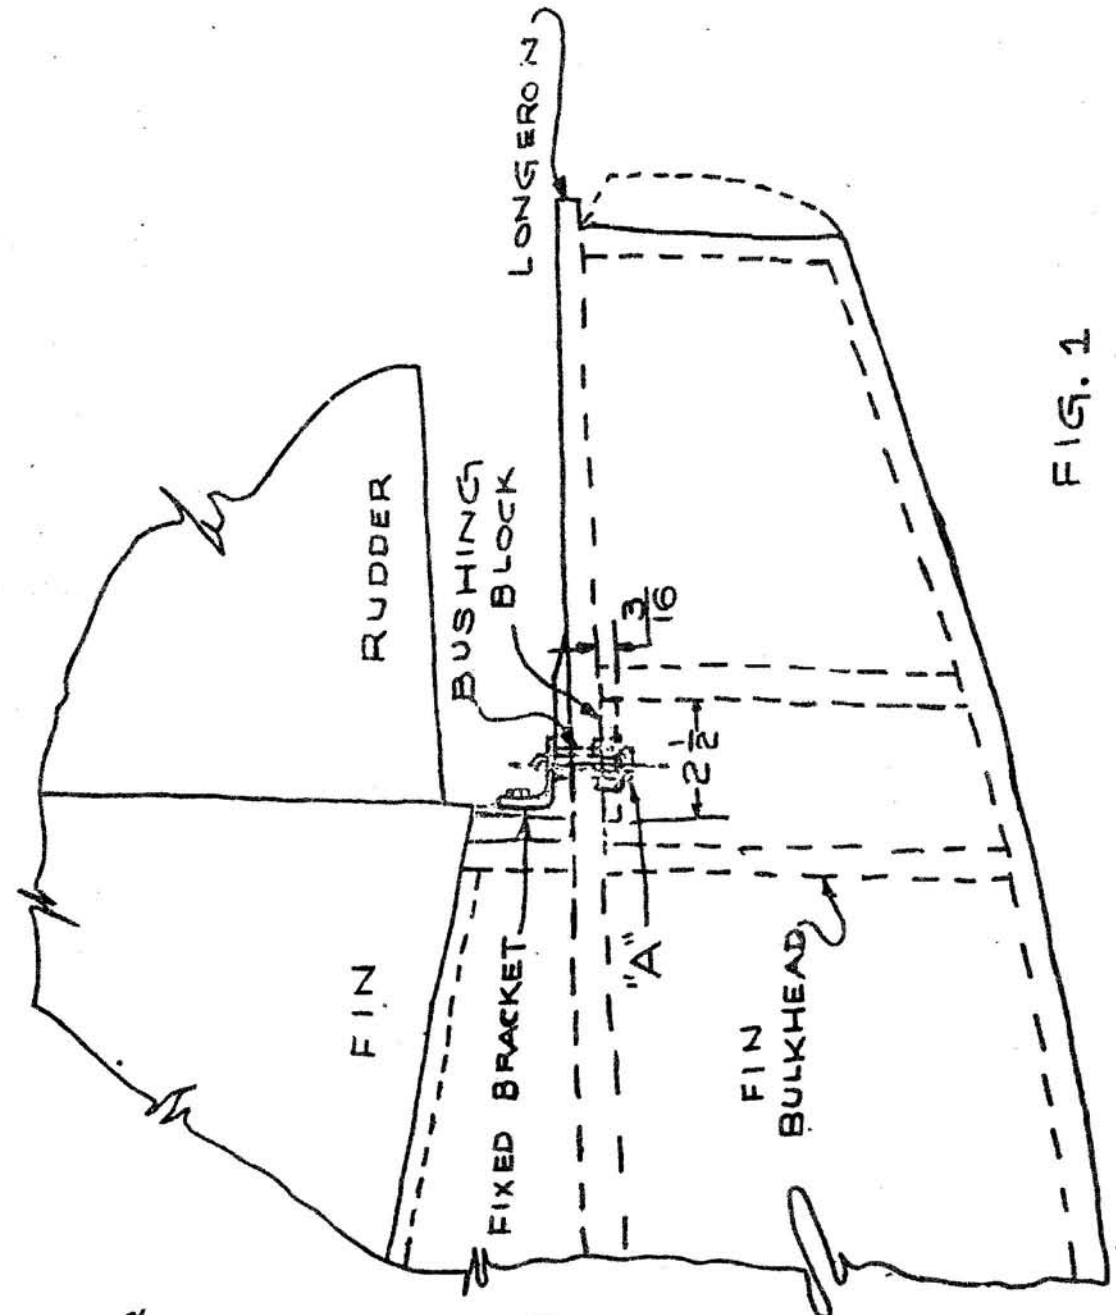
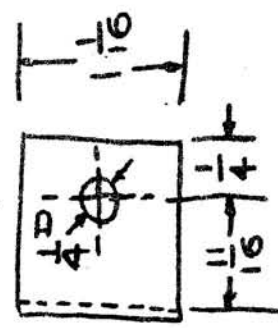
FIG. 1

1. It has come to our attention that the underside of the top longerons at the front stabilizer attachment on some airplanes has become crushed. This appears to be due to any one or all of the following causes: Excessive tightening of the attachment bolt, and improper handling on the ground.

Inspect the under side of the top longerons for crushing at the front stabilizer attachment bolt. Also, inspect the skin just below the top longeron for cracks or splitting.

Glue a piece of aircraft quality birch, maple, or black walnut plywood 3/16" thick 1-1/8" wide and 2-1/2" long to the underside of the longeron as shown in Fig. 1. Use aircraft quality casein glue mixed according to directions.

Reinstall horizontal tail, replacing the front mounting bolts with AN4-16A bolts fixed from rotating as shown on Fig. 1.
