CULVER AIRCRAFT CORPORATION
WICHITA, KANSAS

SERVICE MEMORANDUM

SUBJECT: Adjustment of and Operation of Landing Gear Throttle Inter-connection

TO: Owners of Culver Model LCA & LFA Airplanes

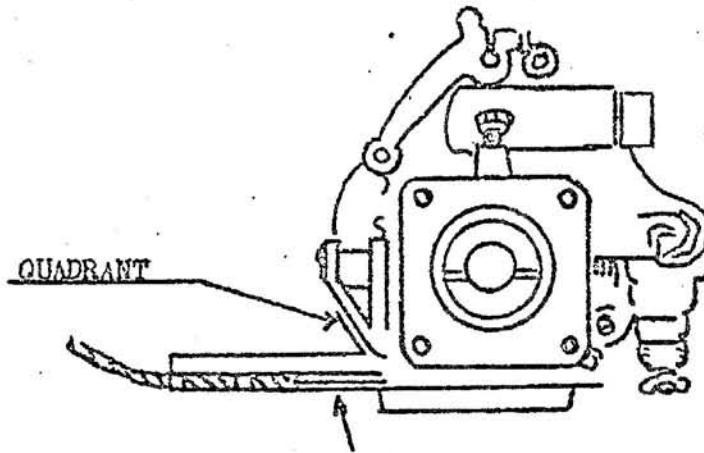
FIG 1.

PLUNGER
Plunger bends quadrant into
carburetor bowl causing throttle
to jam.

Pull all slack out of
plunger while adjusting.

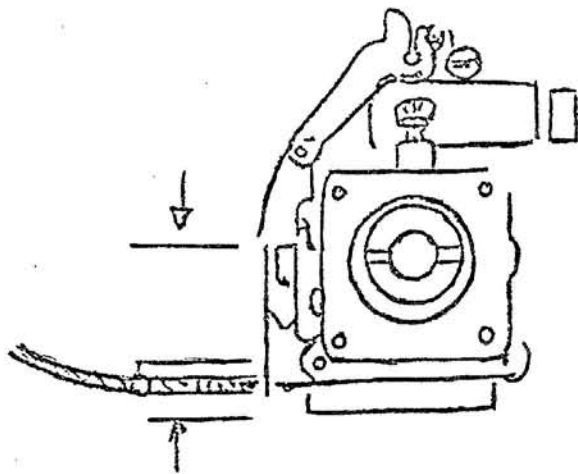
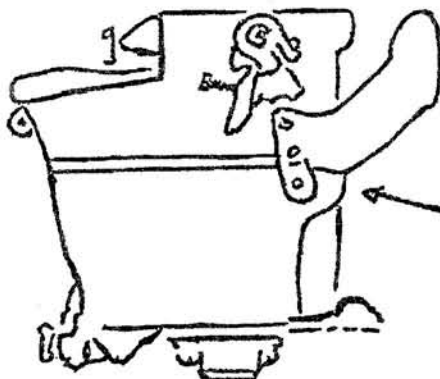
FIG. 3

A careful inspection should be conducted to determine that all connections are in proper order. The clamps at either end of the cable housing should be checked to make absolutely sure that they are holding the housing secure against any possible chance of slippage. For this inspection to be sufficiently thorough, the airplane would be blocked up and the gear retracted, observing the action of the interconnection. The plunger position should be so adjusted that the throttle cannot be pulled back unless the gear is down and locked. There will be considerable play in the flexible control which operated the plunger. When the flexible control was new there was approximately 1/8th inch play but undoubtedly time and usage have increased this value. The plunger should be adjusted to clear the throttle arm plate by approximately 1/8th inch. This 1/8th inch value should be measured with the plunger pulled out with the fingers until all the slack is taken up. See Figure 2. The plunger must not be able to go in front of the plate on the throttle arm when the throttle is closed. See Figure 3.

Plunger to be in area
shown when idling.
WARNING: Never in front
of plate.

Adjust position of quadrant
by loosening screws and shift-
ing quadrant to correct position
and tighten screws.
